OREGON CORNER RESTORATION FORM

Section County	15 Umatilla	Township Date:	<u>5N</u> Range Februar <u>y 18, 2012</u>	36E_	
Corner De	esignation:	5N36J13	·	٧	Condition Report Only Not found Remonumented
Corner common to sections 9, 10, 15, and 16, T5N, R36E, W.M., Umatilla County, Oregon.				^	Unrecorded Surveyed in

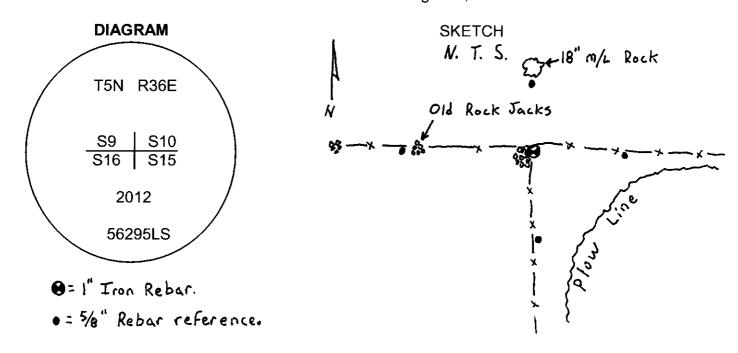
Monument and Accessories found: (condition and source) The mound of stone at the fence corner with fences running east, west and south.

At the corner point I set a 1" x 24" Iron Rebar with a 2" Al cap driven flush with the ground. The cap is stamped as shown in the diagram above.
